PRELIMINARY ANALYSIS OF A 2000 PONTIAC GTP

Insured: Ronald Shipka Enterprises
Claim Number: Seneca 9CCN001

ANALYSIS OF A 2000 PONTIAC GTP

Second Report

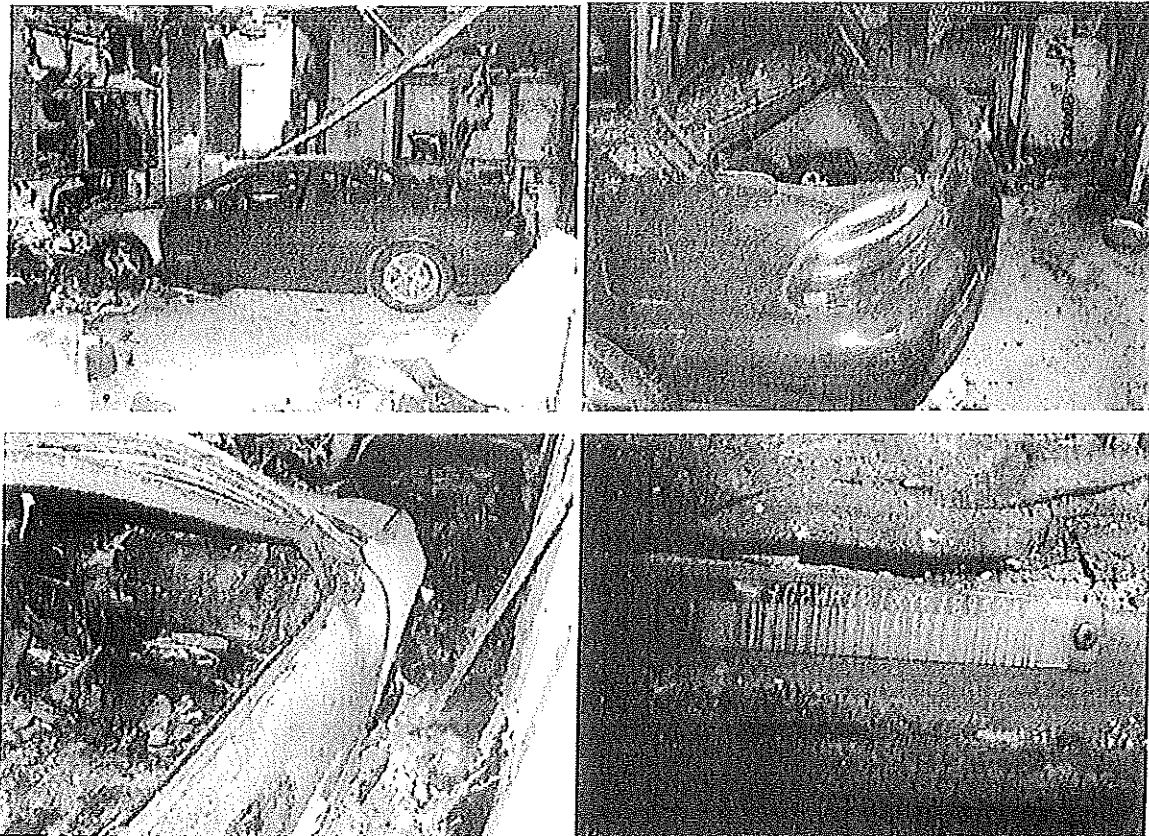
Figure 1 shows various views of the vehicle and the VIN plate. According to the vehicle owner, she parked the car at around 6:30 pm. The fire started at approximately 7pm.

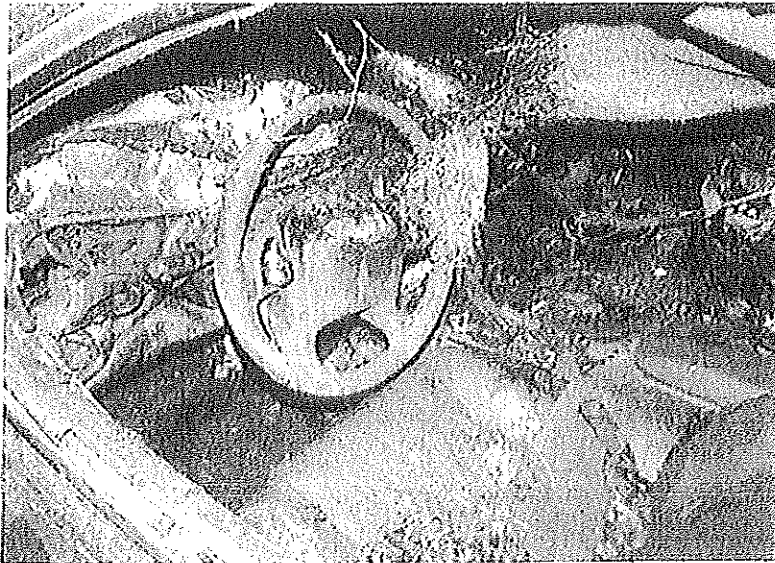
Figure 2 shows the occupant compartment which was in relatively good condition. Figure 3 shows a severely oxidized hood and front fenders, suggesting a fire origin in the engine compartment.

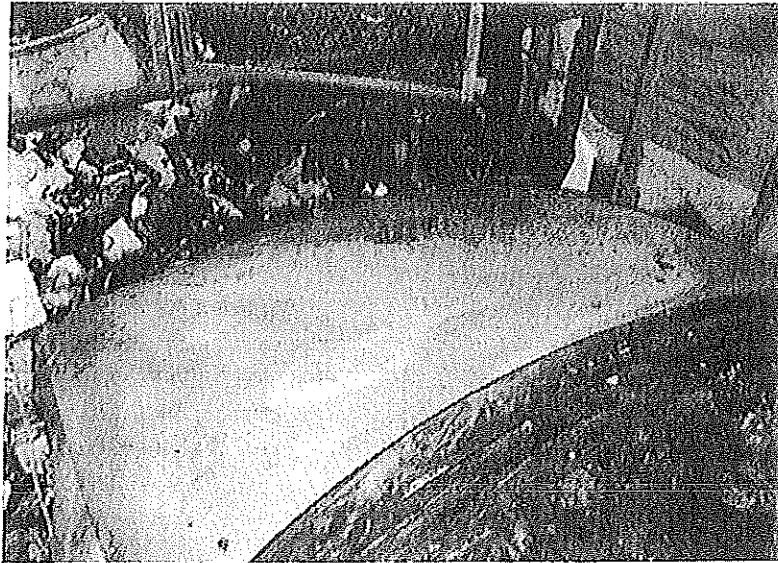
Figure 4

In Figure 4, the highest temperatures appear to be in the engine compartment toward the front of the vehicle. Figure 5 is a view of the front of the engine, showing severe damage.

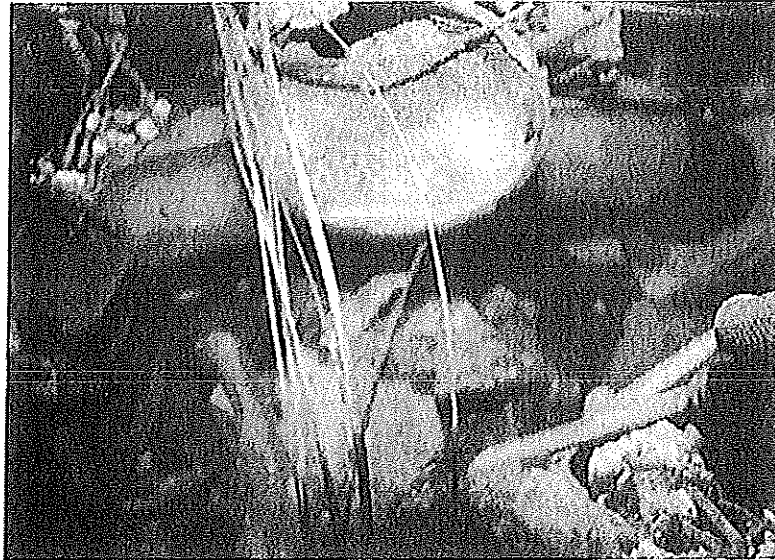
Figure 6 shows the throttle body which is less thermally damaged. Figure 7 shows the badly damaged radiator, suggesting a fire origin near the front of the engine.

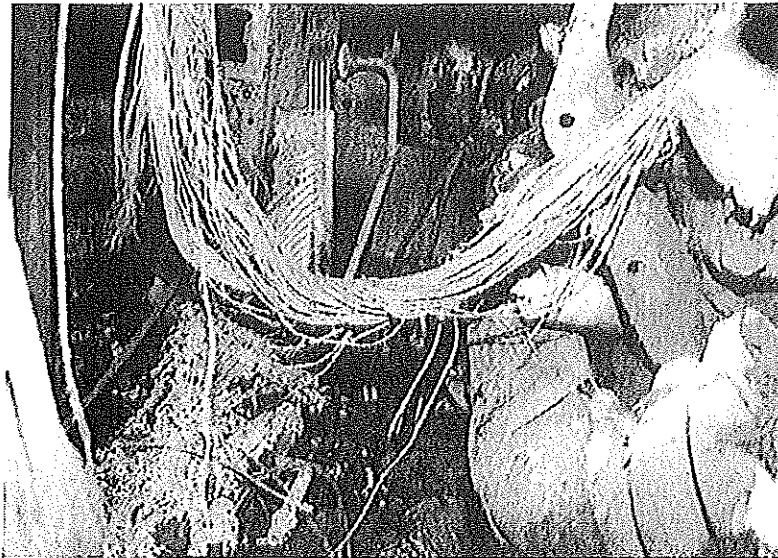
Figure 7

The fire origin and circumstances of the fire development in this vehicle match the description of an oil leak having caused this fire.

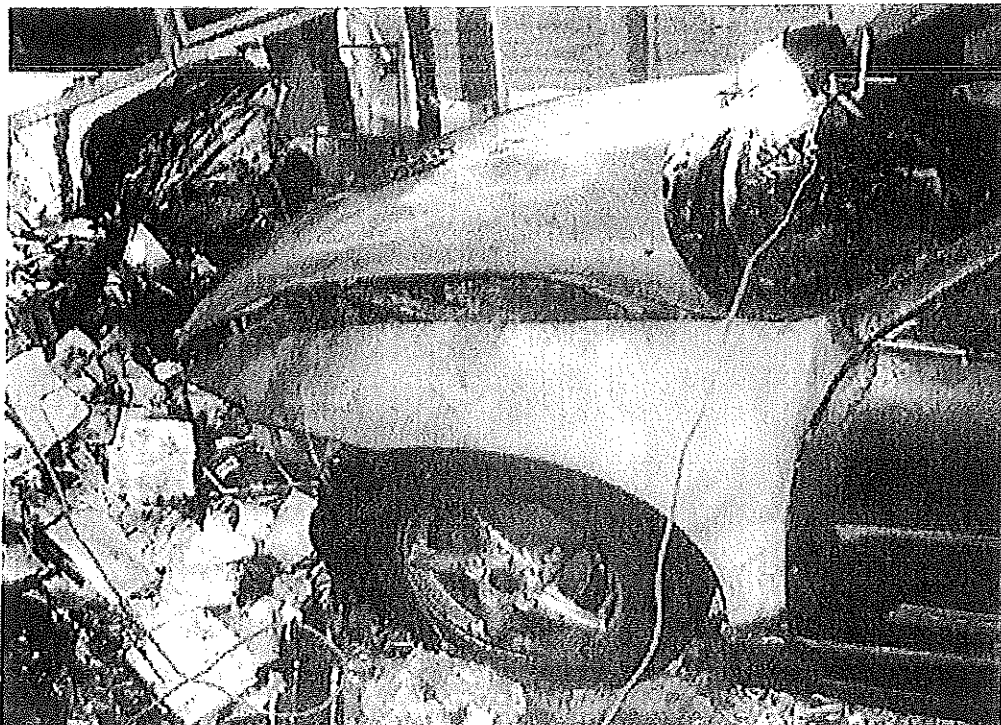
Figure 1 is a view of the front of the vehicle prior to hood removal.

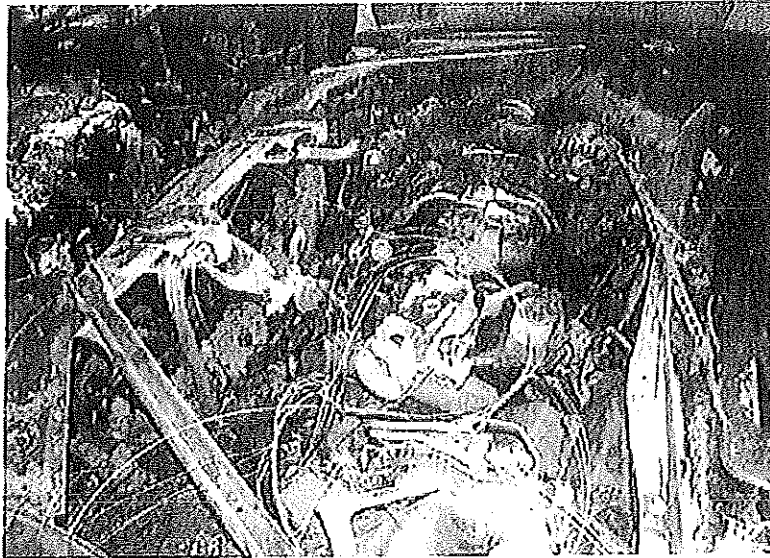
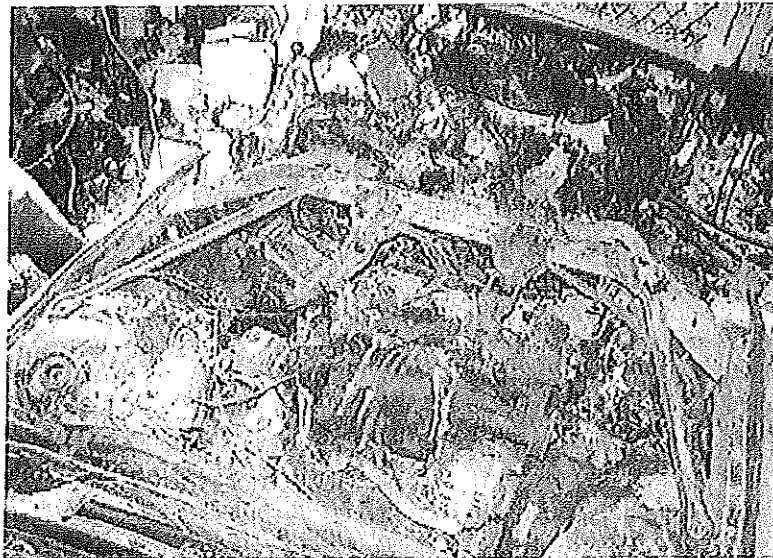
Figures 2 and 3 show views of the engine compartment with the hood removed. The two hood hinge bolts were removed. The front striker on the hood latching mechanism was cut away.

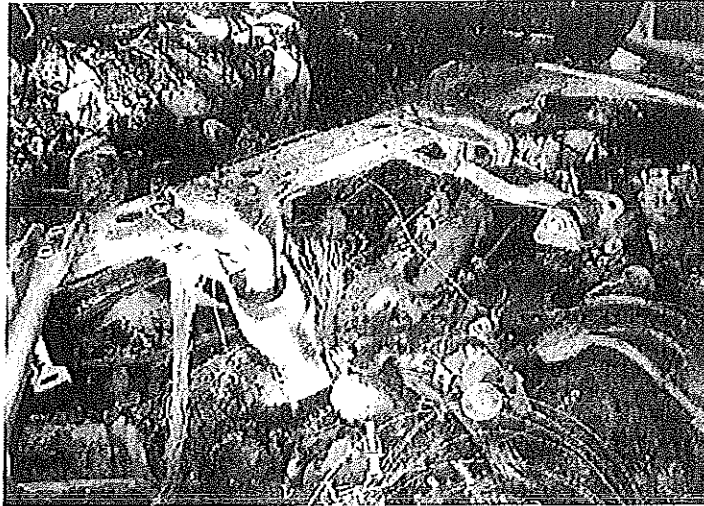
Figure 4 is a close-up of the fire origin area which is in front of the engine. The V pattern at the radiator suggests a fire origin at the front of the engine. Many of the polymer components at the back of the engine showed significantly less damage.

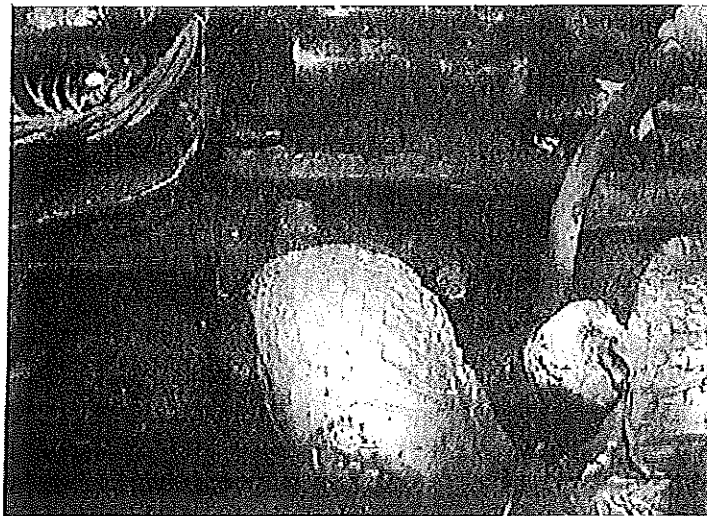
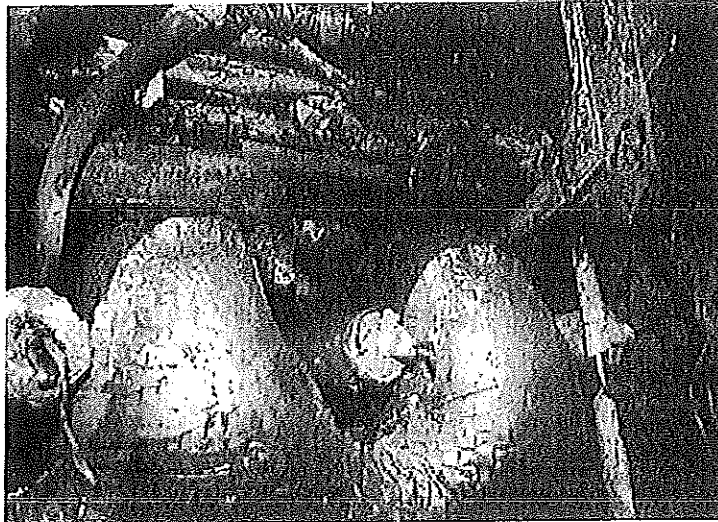
Figures 5 and 6 show views of the interface between the valve cover and the engine. This is the area where oil leakage occurs, according to the General Motors recall shown below. Thermal damage in this area is consistent with oil leakage through the valve cover gasket. Thermal damage inside the engine compartment is consistent with this recall.

1. In my opinion, the probable cause of the fire in this vehicle is engine oil leakage onto hot exhaust components.
2. In my opinion, the fire is a result of a defect described in the recall mentioned above.

BY LETTER DATED MARCH 12, 2008, GENERAL MOTORS CORP. (GM) HAS NOTIFIED THE AGENCY THAT IT WILL CONDUCT A SAFETY RECALL (IDENTIFIED BY NHTSA RECALL NUMBER 08V-118) TO ADDRESS A DEFECT IN APPROXIMATELY 207,542 MODEL YEAR (MY) 1997-2003 BUICK REGAL GS AND PONTIAC GRAND PRIX GTP VEHICLES EQUIPPED WITH THE L67 SUPERCHARGED VERSION OF GM'S 3800 SERIES II V6 ENGINE. THE RECALLED REGAL GS VEHICLES WERE BUILT FROM AUGUST 1996 TO JUNE 2003 AND THE GRAND PRIX GTP FROM MARCH 1996 THROUGH JANUARY 2003. ACCORDING TO GM, OIL MAY ESCAPE PAST THE VALVE COVER GASKET ON THE FRONT CYLINDER BANK (CYLINDERS 1-3-5) AND DEPOSIT ONTO HOT EXHAUST SYSTEM COMPONENTS. UNDER CERTAIN CONDITIONS, IT IS POSSIBLE FOR THIS OIL TO IGNITE A SMALL PILOT FLAME, WHICH MAY SPREAD TO THE ADJACENT PLASTIC SPARK PLUG WIRE CHANNEL, THE SPARK PLUG WIRES THEMSELVES, THE PLASTIC ENGINE COVER, AND OTHER UNDER HOOD COMPONENTS. REPORTS INDICATE THIS MOST OFTEN OCCURS ON HIGHER-MILEAGE VEHICLES SHORTLY AFTER THE VEHICLE HAS BEEN DRIVEN AND THEN PARKED. TYPICALLY, THE FIRE WAS DISCOVERED WITHIN 5 TO 15 MINUTES AFTER THE VEHICLE WAS PARKED. DURING THIS TIME WINDOW, UNDER HOOD TEMPERATURES MAY BECOME ELEVATED. SUCH ELEVATED TEMPERATURES COMBINED WITH A LACK OF AIRFLOW THROUGH THE ENGINE COMPARTMENT MAY PERMIT A SMALL PILOT FLAME TO PROPAGATE AND IGNITE OTHER FUEL SOURCES. TO CORRECT THE SAFETY DEFECT, GM WILL INSTALL AN IMPROVED DESIGN FRONT VALVE COVER GASKET AND SPARK PLUG WIRE RETAINER.
